PROJECT:  
**Columbus Flood Risk Management Plan**

TITLE:  
**Flooding Depths along County Road 550 North (Big Slough Creek)**

EXHIBIT **31**

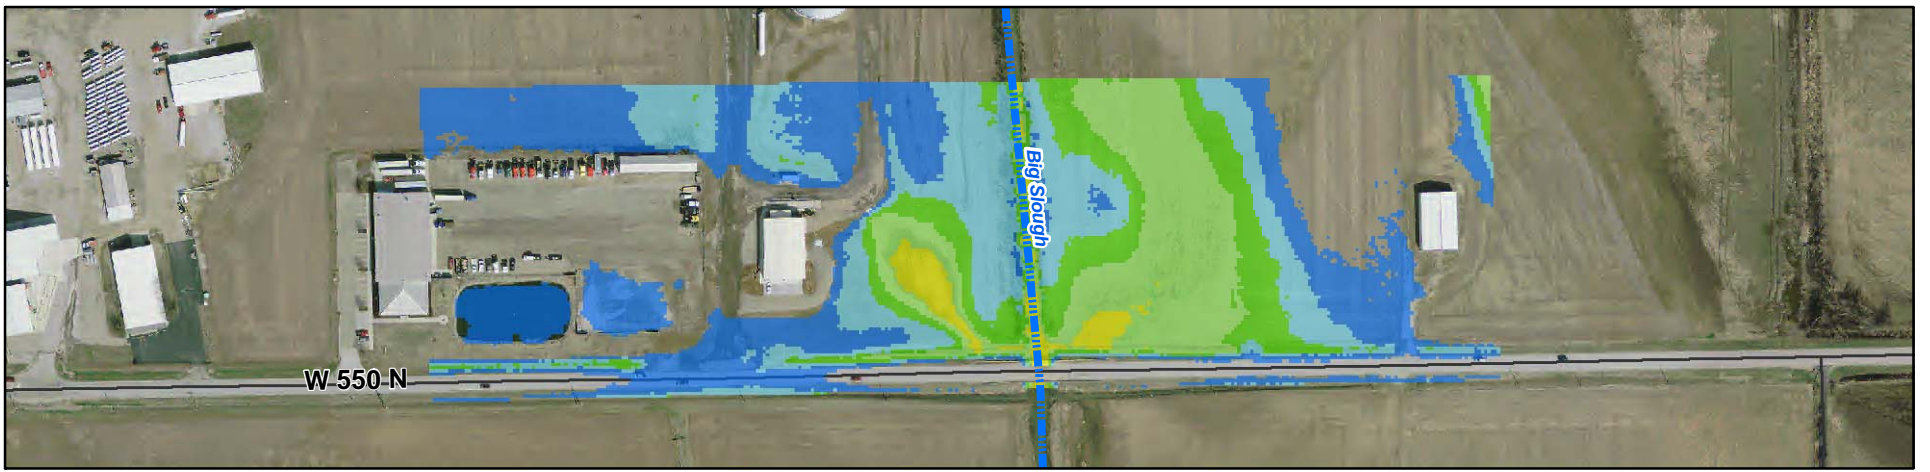
### 10-Year Flooding Event

## Flooding Depths along County Road 550 North (Big Slough)
