Columbus Flood Risk Management Plan

TITLE: Flooding Depths along County Road 325 West (Catherine Creek, Driftwood River Backwater)

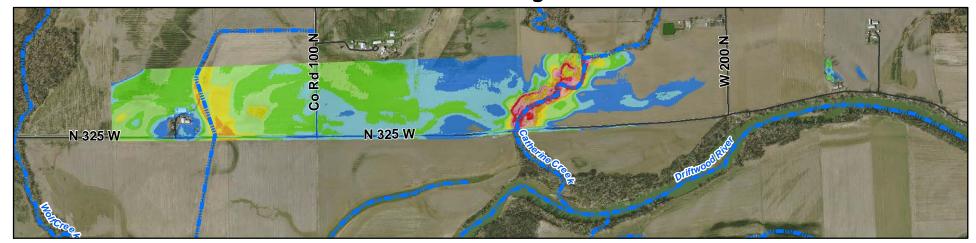
10-Year Flooding Event

Flooding Depths along County Road 325 West

(Catherine Creek, Driftwood River Backwater)
